Technical Inspection Report  
Bureau of Ordnance Group

OPERATION CROSSROADS.

TESTS 'A' AND 'B'.  
VOLUME III.  
PART I.  
Photographic  
Appendix [u]. 8

Subject: Bureau of Ordnance Material Group Final Report for Tests "A" & "B".

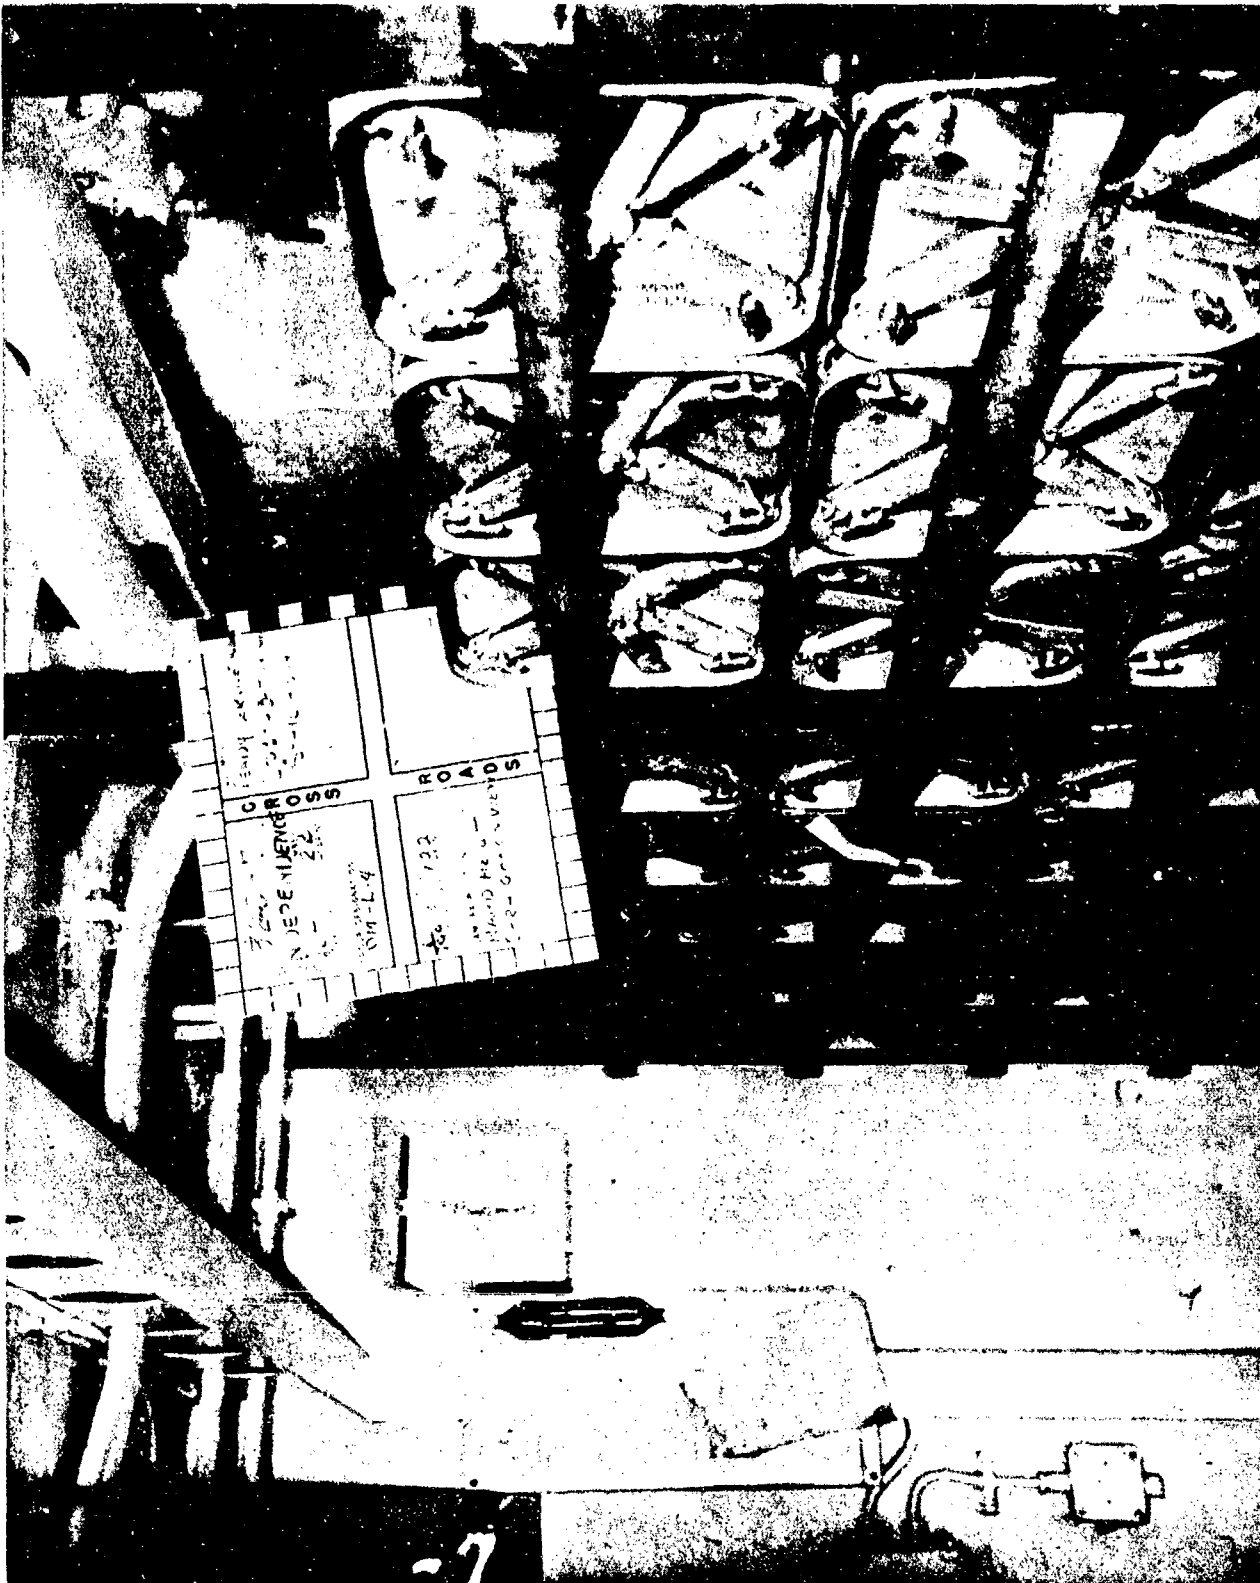
U.S.S. INDEPENDENCE (CVL-22) - Before Able  
Shows the 40 MM Ammunition Stowage in Magazine,  
C-0303-M prior to Test "A". All ammunition is  
service ammunition.  
Photo. No. EA-CF-63-320-7.

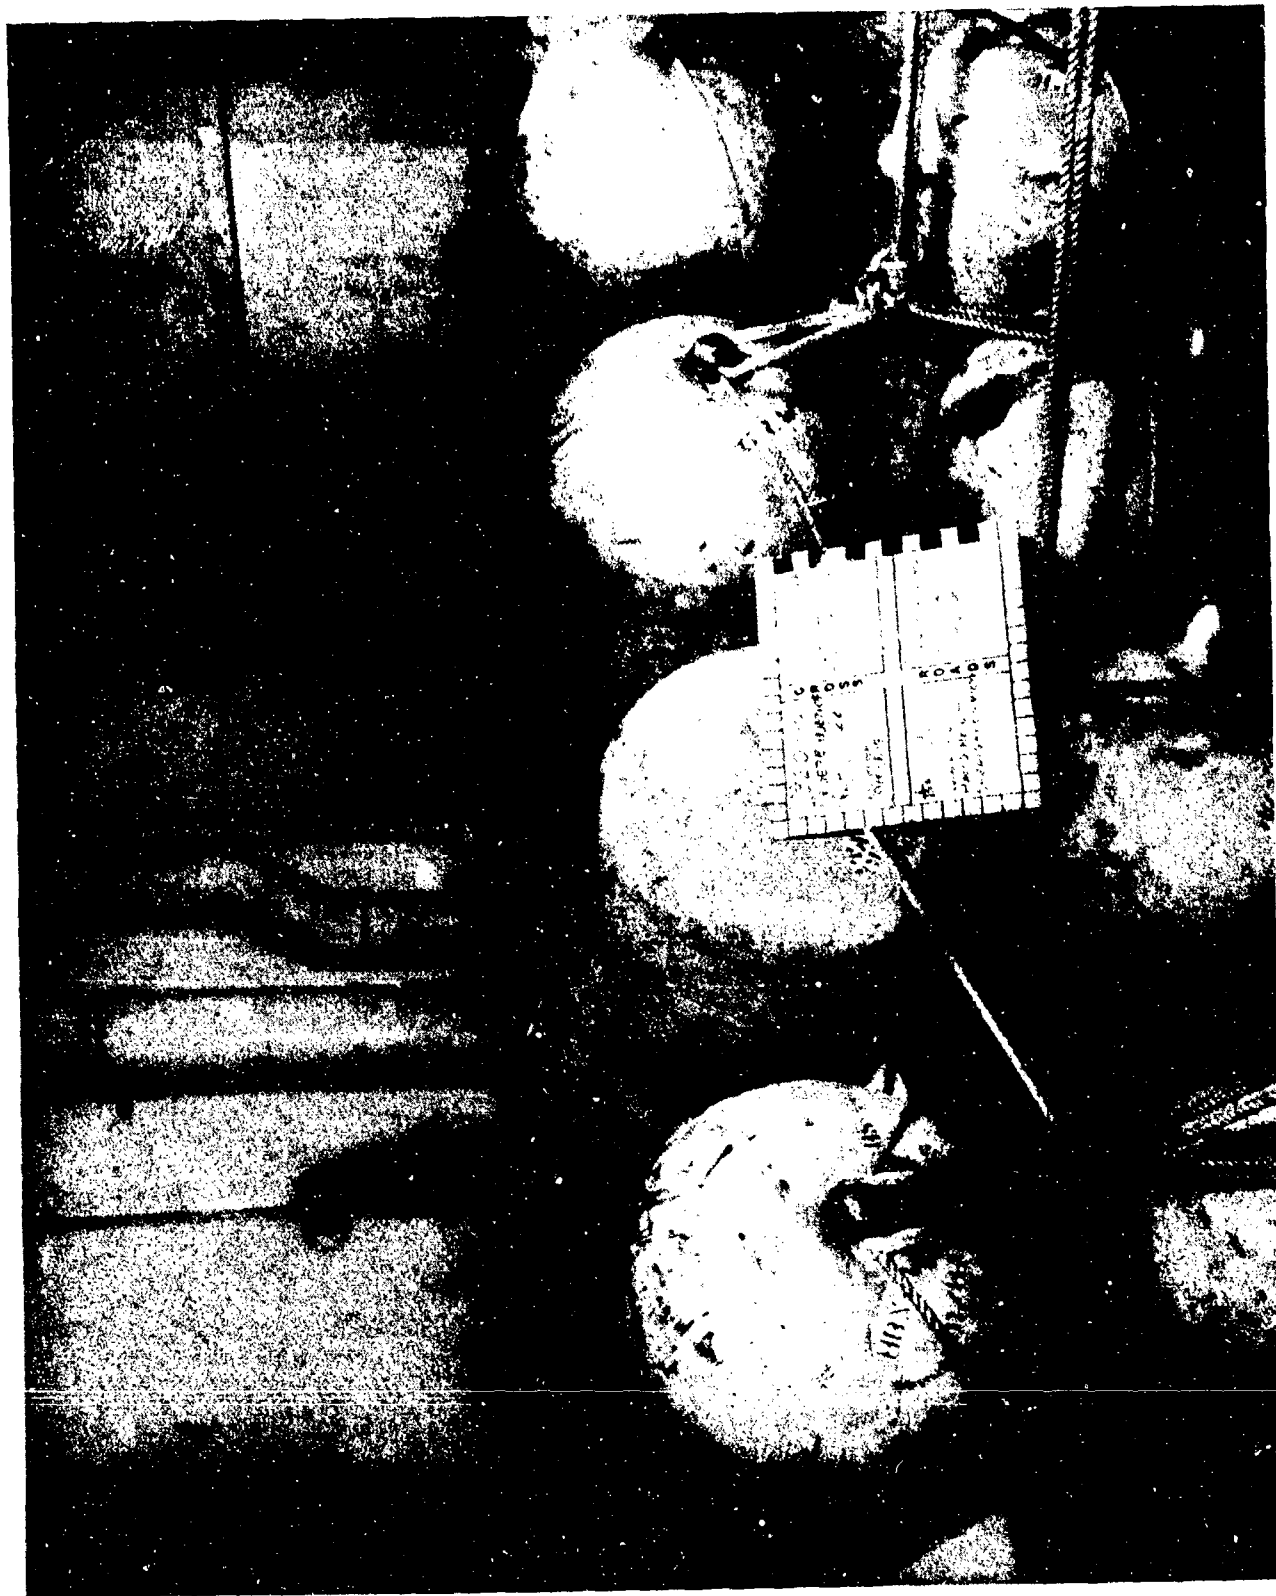
U.S.S. INDEPENDENCE (CVL-22) - Before Able  
Shows the Aircraft Ready Torpedo Stowage in Compartment  
C-101-B prior to Test "A". Torpedoes are Service Torpedoes.  
FBX loaded.  
Photo. No. RA-CR-63-320-11.

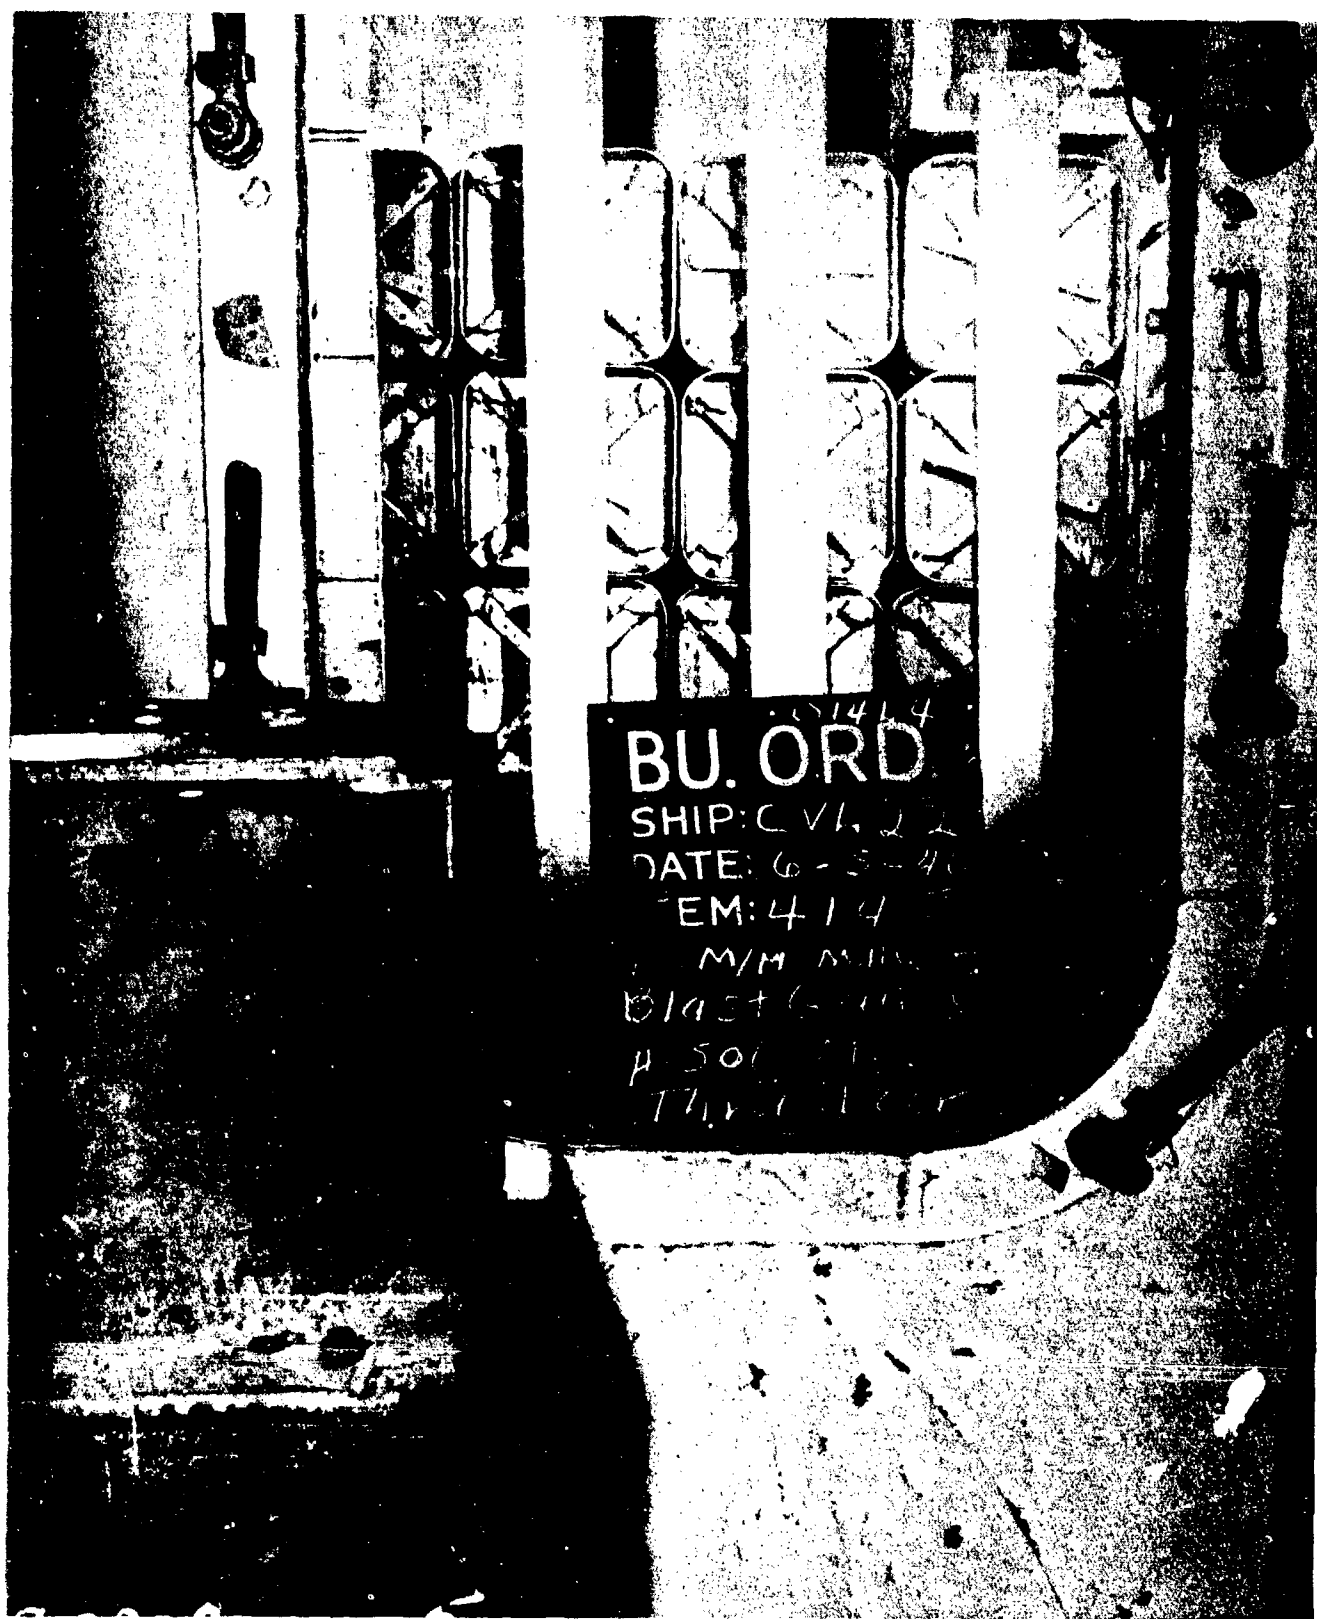
U.S.S. INDEPENDENCE (CVL-22) - Before Able  
Shows the 40 MM Magazine, A-506-M and Blast Instrument  
in position for Test "A". All ammunition is Service Ammunition.  
Photo. No. BA-Ck-92-414-5.

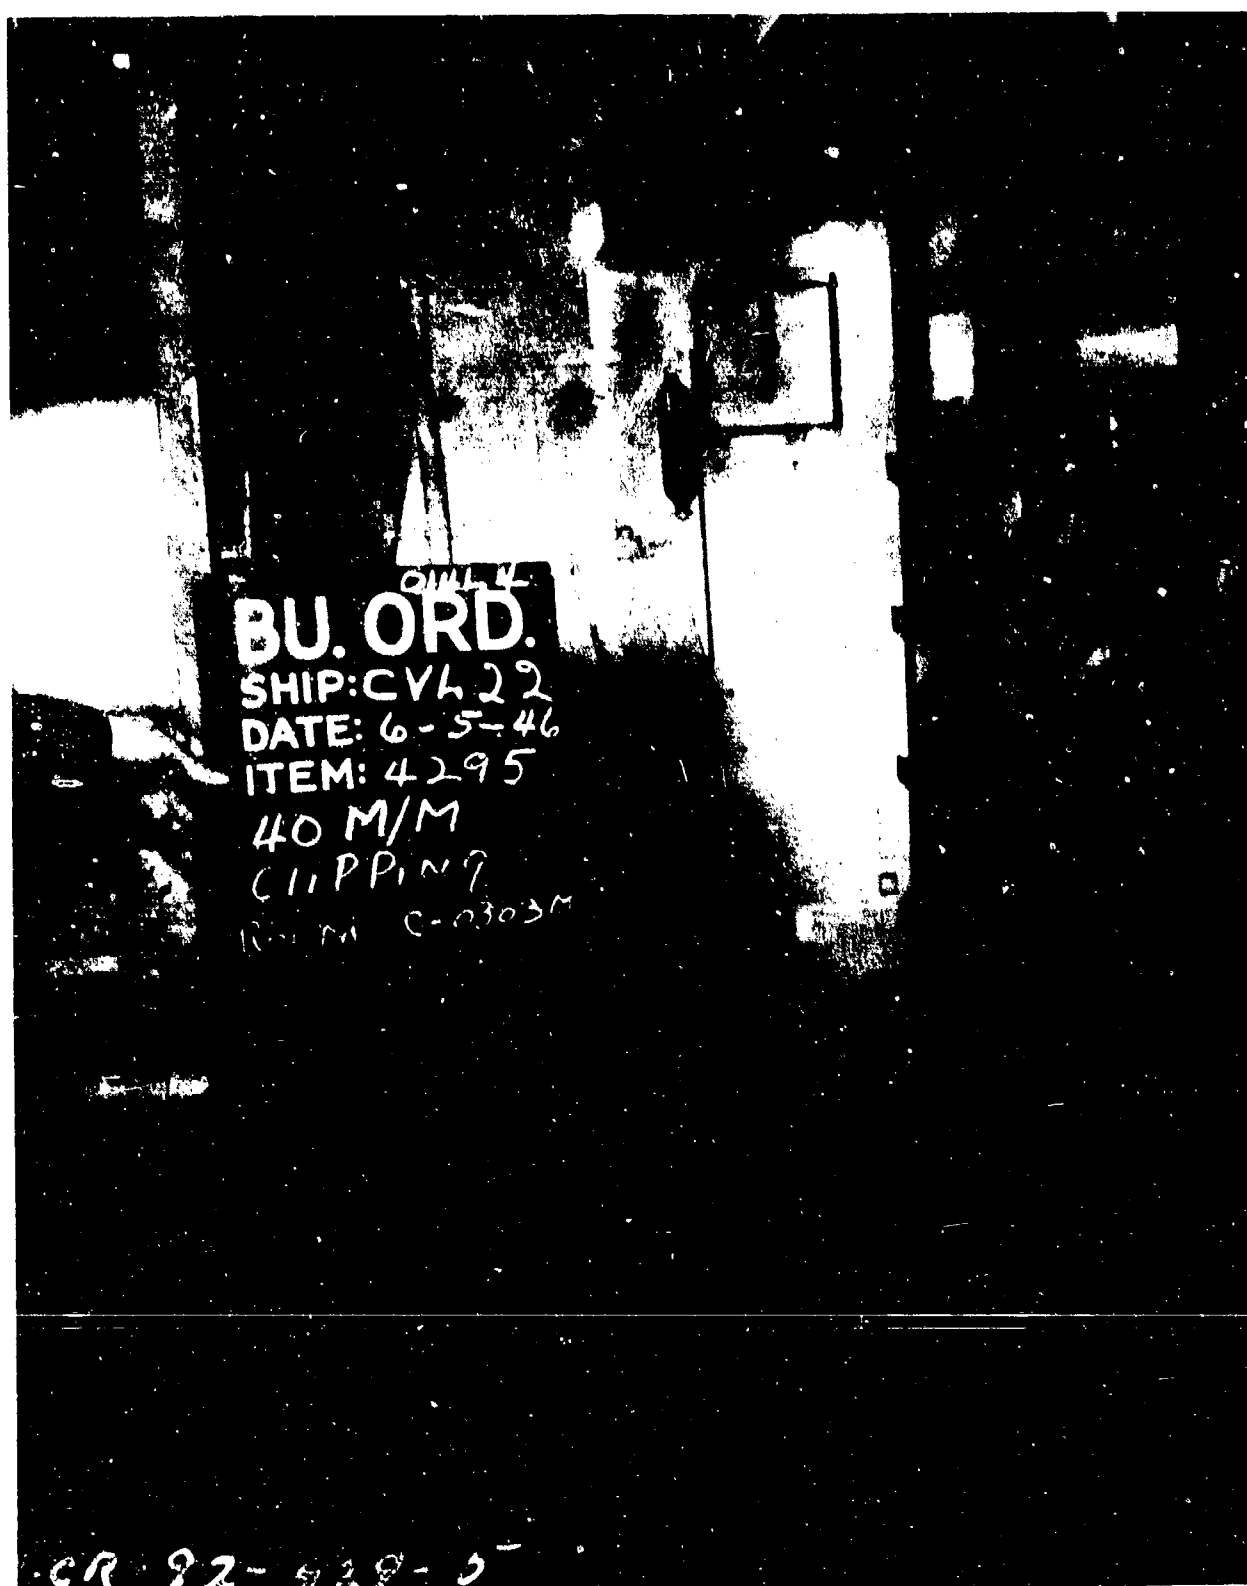
U.S.S. INDEPENDENCE (CVL-22) - Before Able  
Shows the 40 MM Clipping Room, C-0303-M, prior  
to Test "A". All ammunition is Service Ammunition.  
Photo. No. RA-CR-92-429-5.

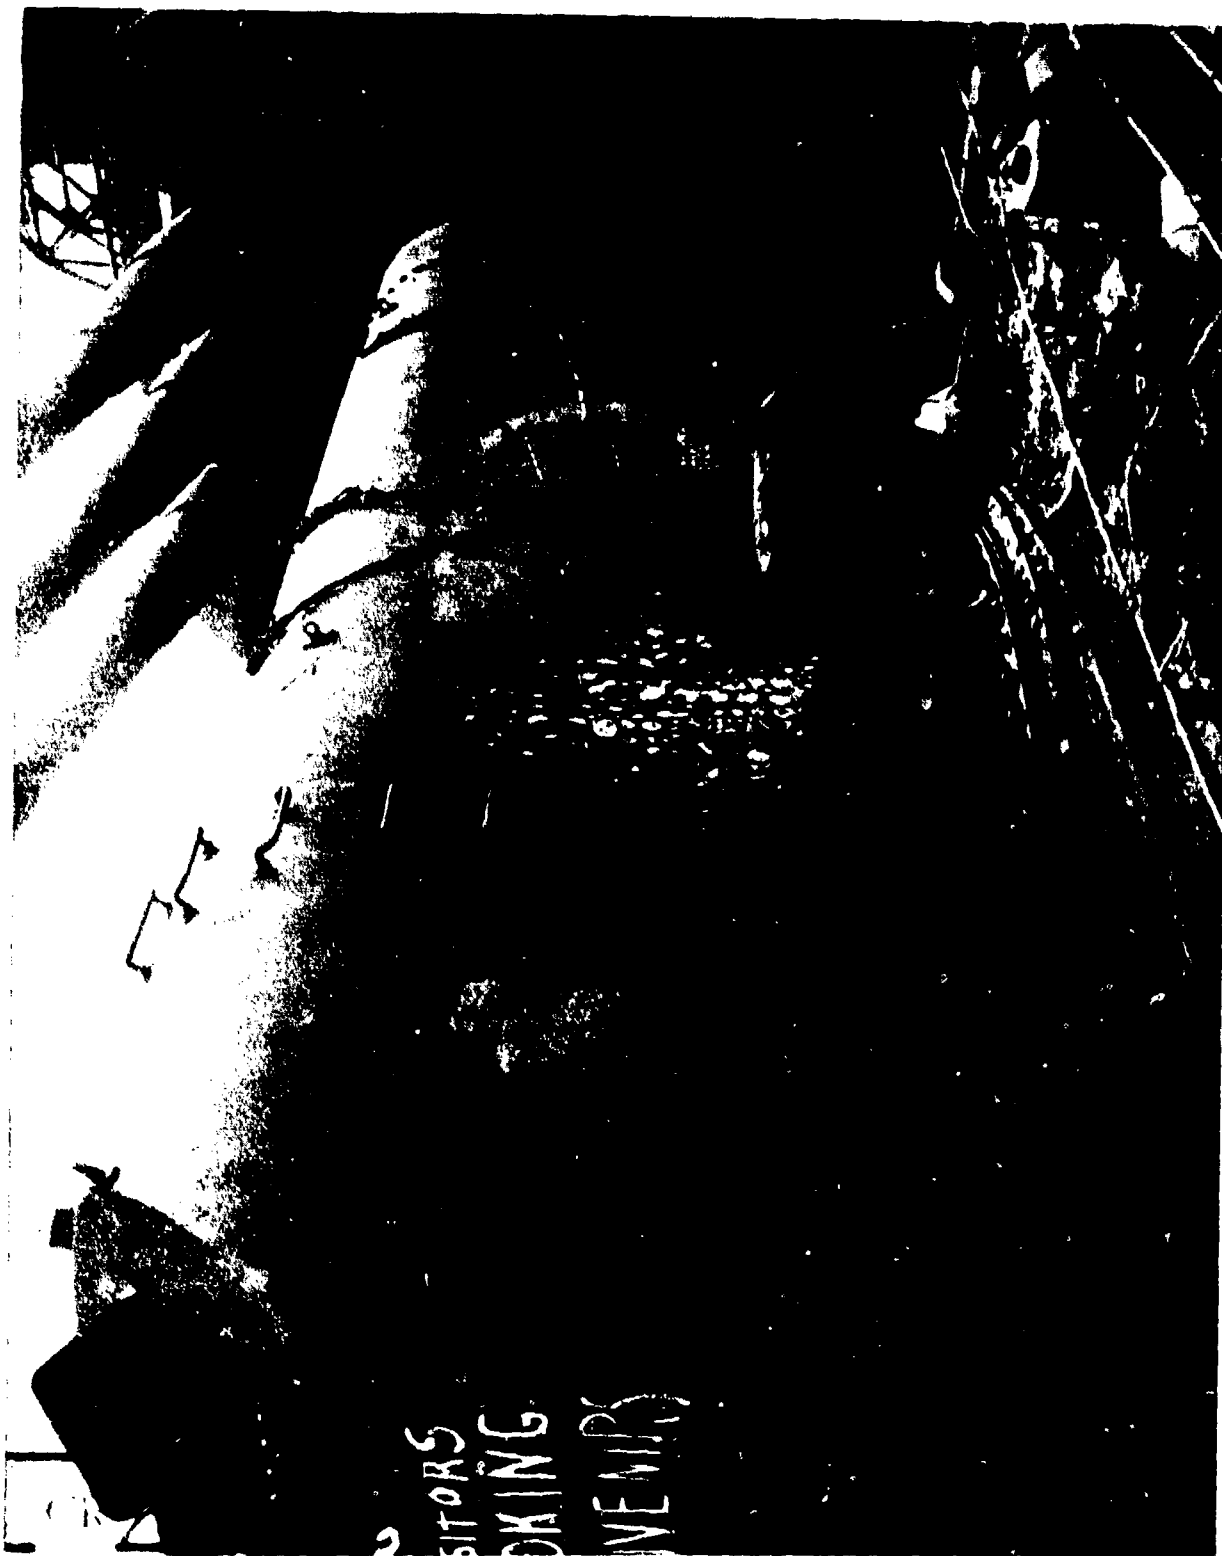
U.S.S. PENSACOLA (CA-24) - After Able  
Shows the location of the fire adjacent to turret No. 4  
and its effect on the turret. Heat generated from the  
burning Quartermaster materials on display caused slight  
scorching to charring of paint on the turret. Ammunition  
inside the turret and ammunition on the gun trays was not  
affected.  
Photo. No. AA-CR-92-1778-2.

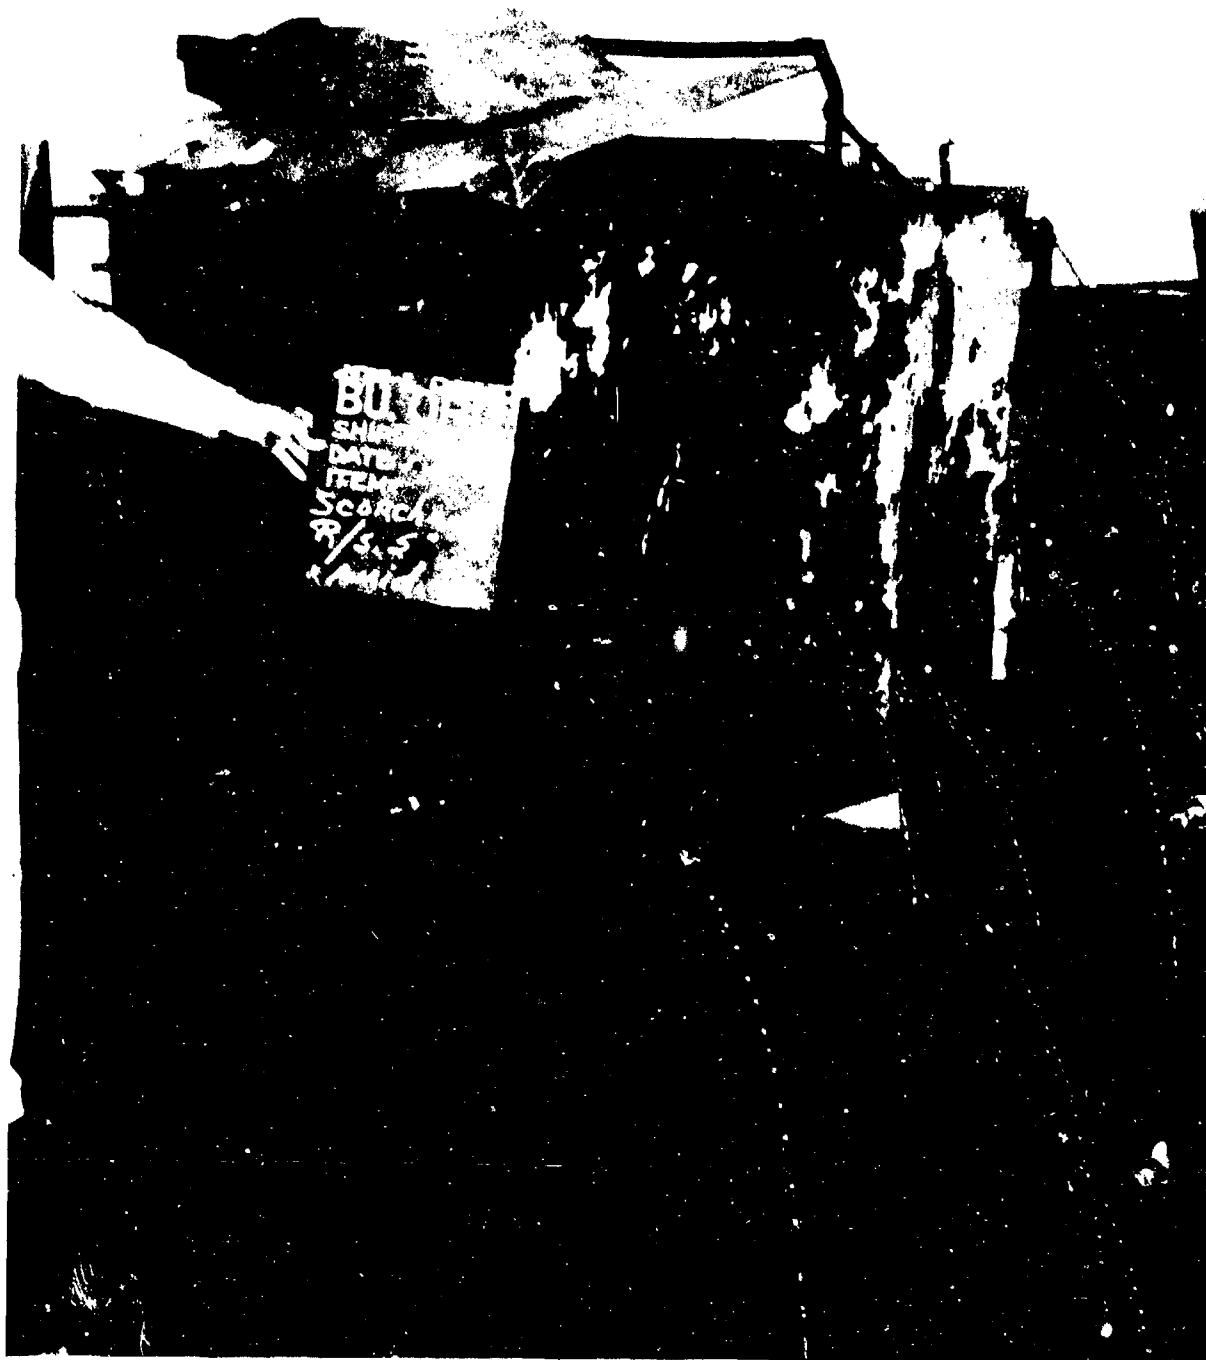
U.S.S. FIRMAGORA (CA-24) - After Able  
Shows the extent of damage and intensity of heat as a  
result of the Atom Bomb Flash. It is worthy to note that  
the paint inside the 5"/25 Ammunition Ready Service Locker  
was not harmed nor did the maximum and minimum register  
any abnormal temperatures. The ammunition suffered no  
damage.  
Photo. No. AA-CR-87-2539-7.

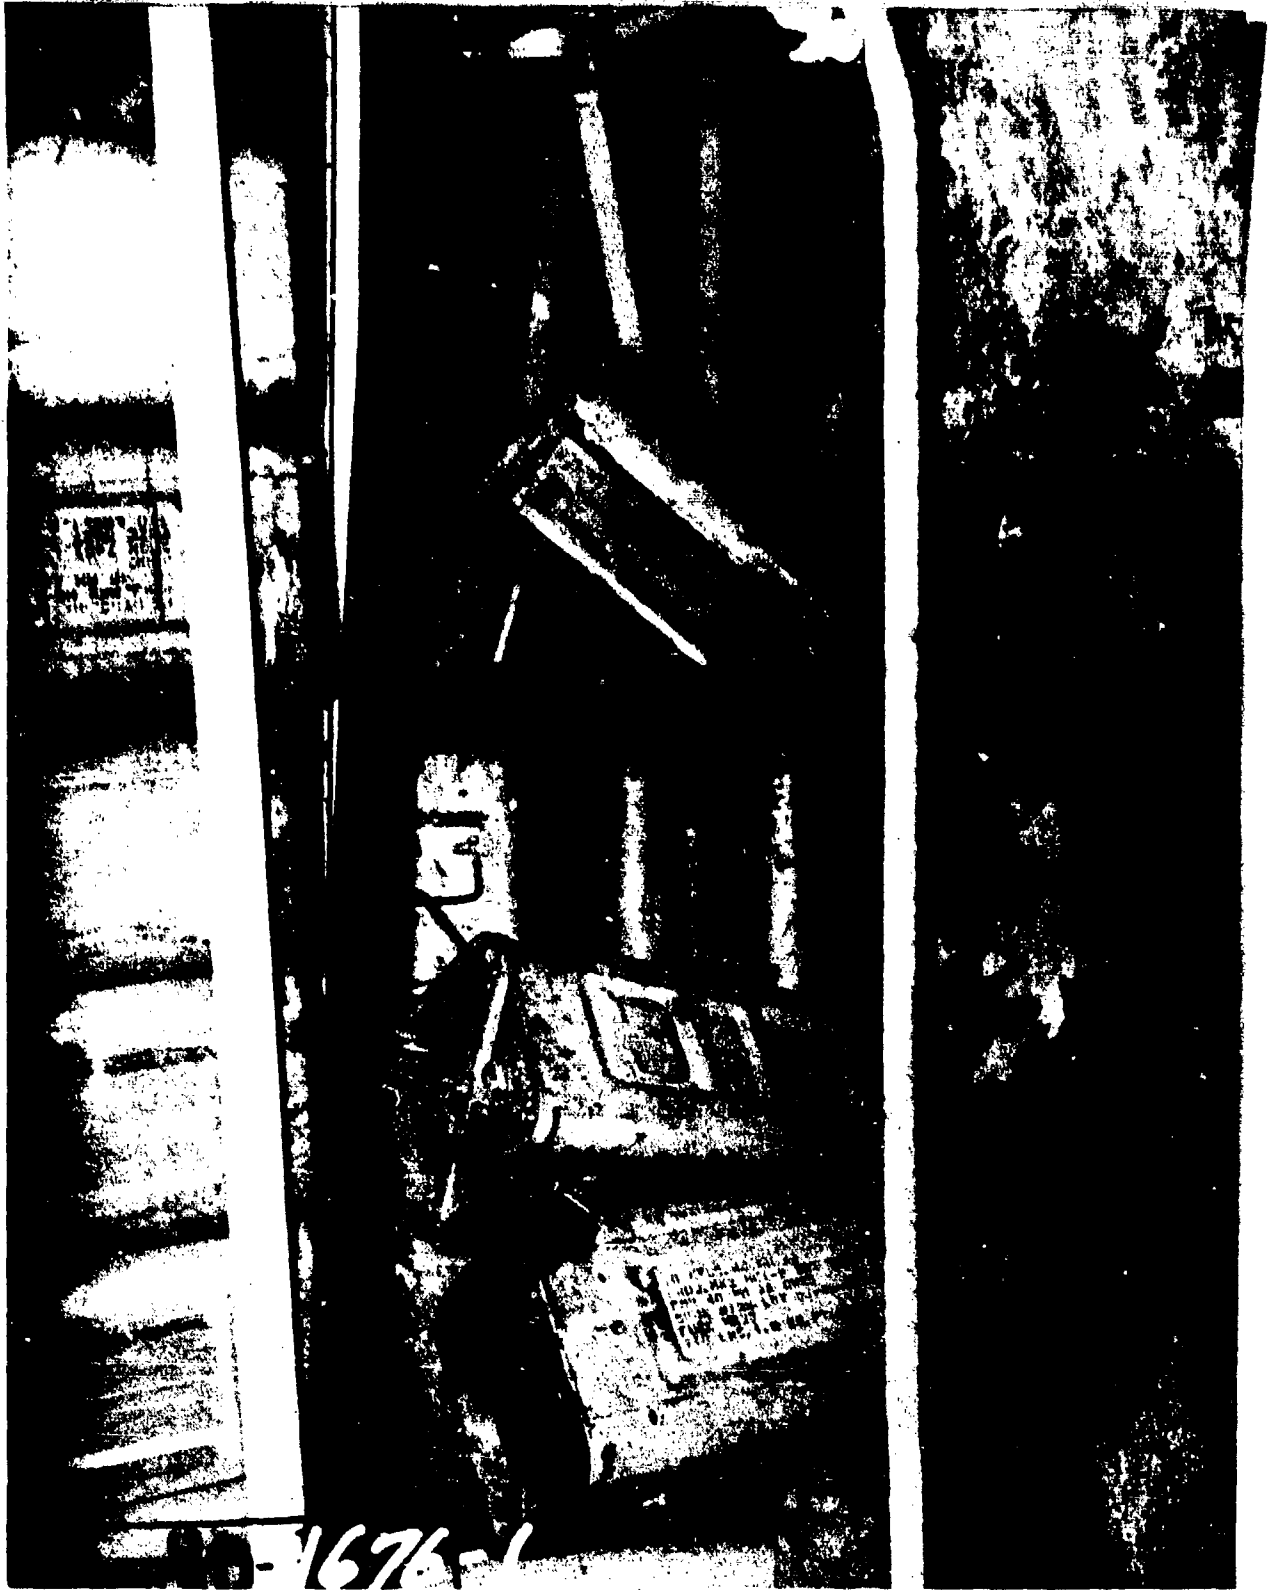
U.S.S. PENSACOLA (CA-24) - After Baker  
Shows the effect of shock to the 40 MM  
Ammunition Storage. The failure of  
ladders and stanchions was marked.  
Photo. No. AB-CR-80-1676-1.

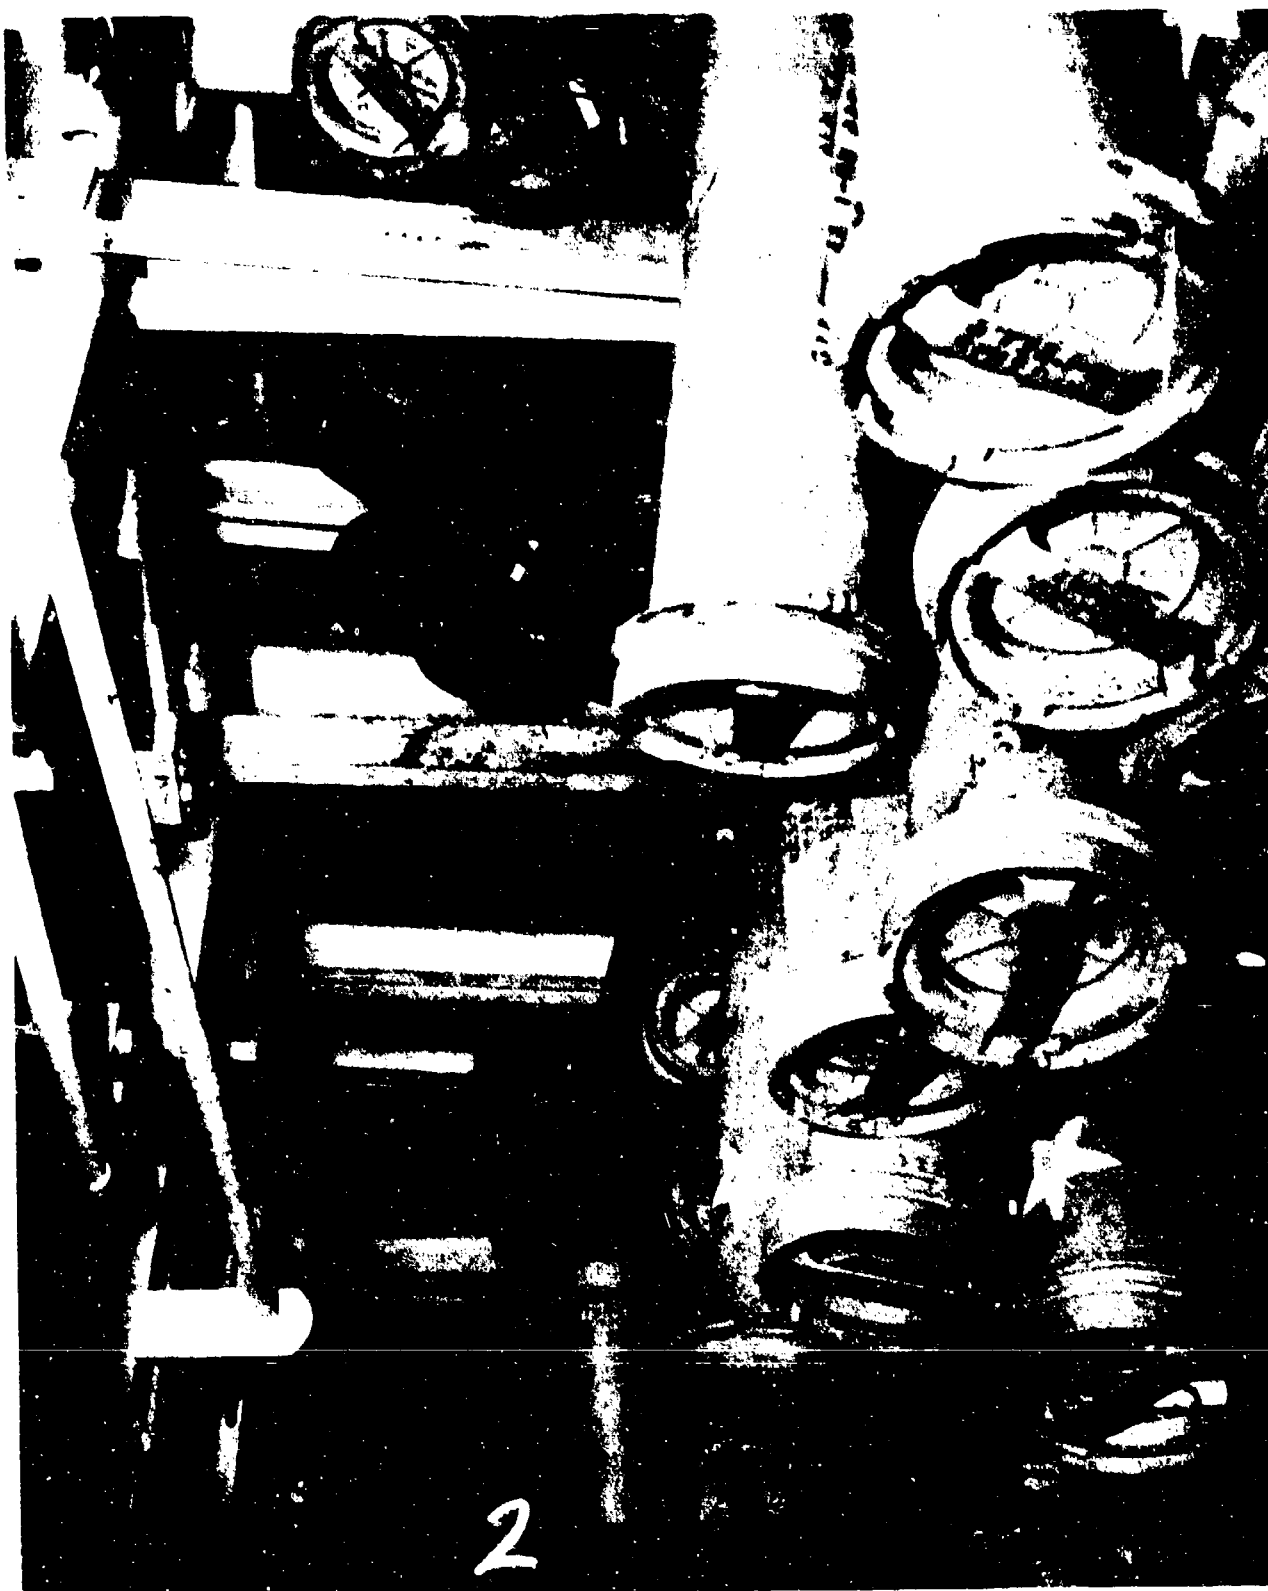
U.S.S. PENSACOLA (CA-24) - After Baker  
Shows the effect of shock to the 5"/25  
Ammunition Stowage. The failure of battens  
and stanchions was marked.  
Photo. No. AB-CR-80-1676-2.

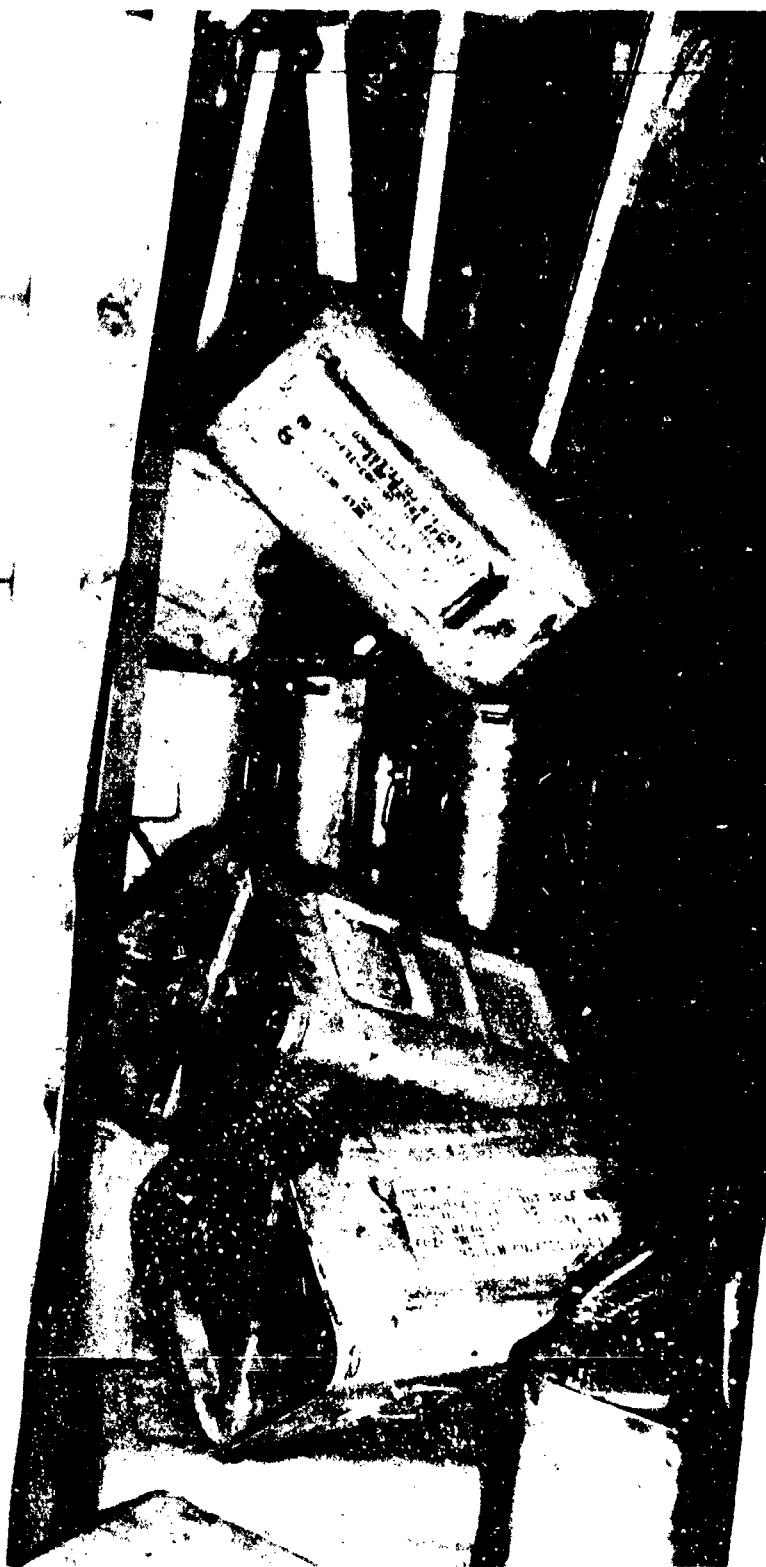
U.S.S. PENSACOLA (CA-24) - After Baker  
Shows the effect of shock to the 40 MM  
Ammunition Stowage. The failure of battens  
and stanchions was marked.  
Photo. No. AH-CR-100-4205-3.

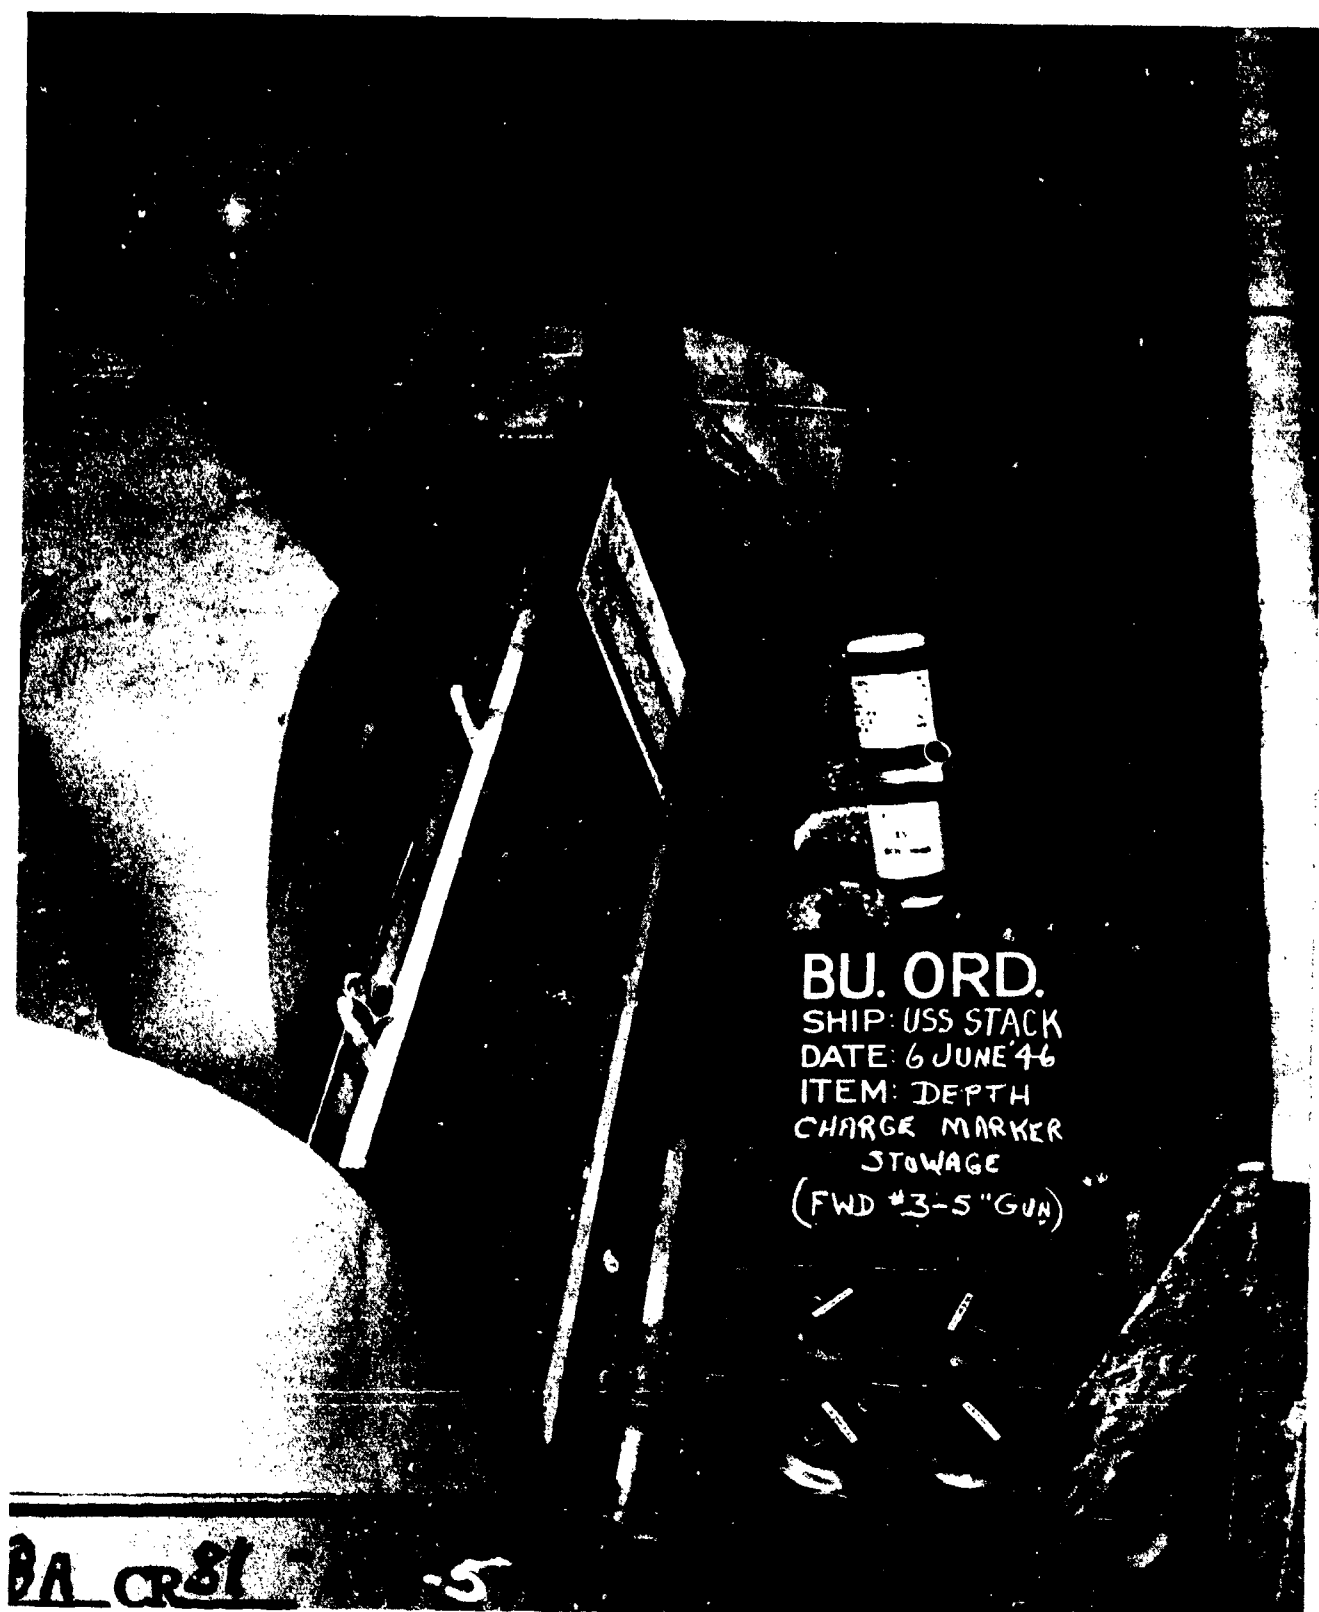
U.S.S. STACK (LD-406) - Before Able  
Shows the depth charge marker stowage  
prior to Test "A".  
Photo. No. BA-CH-81-415-5.

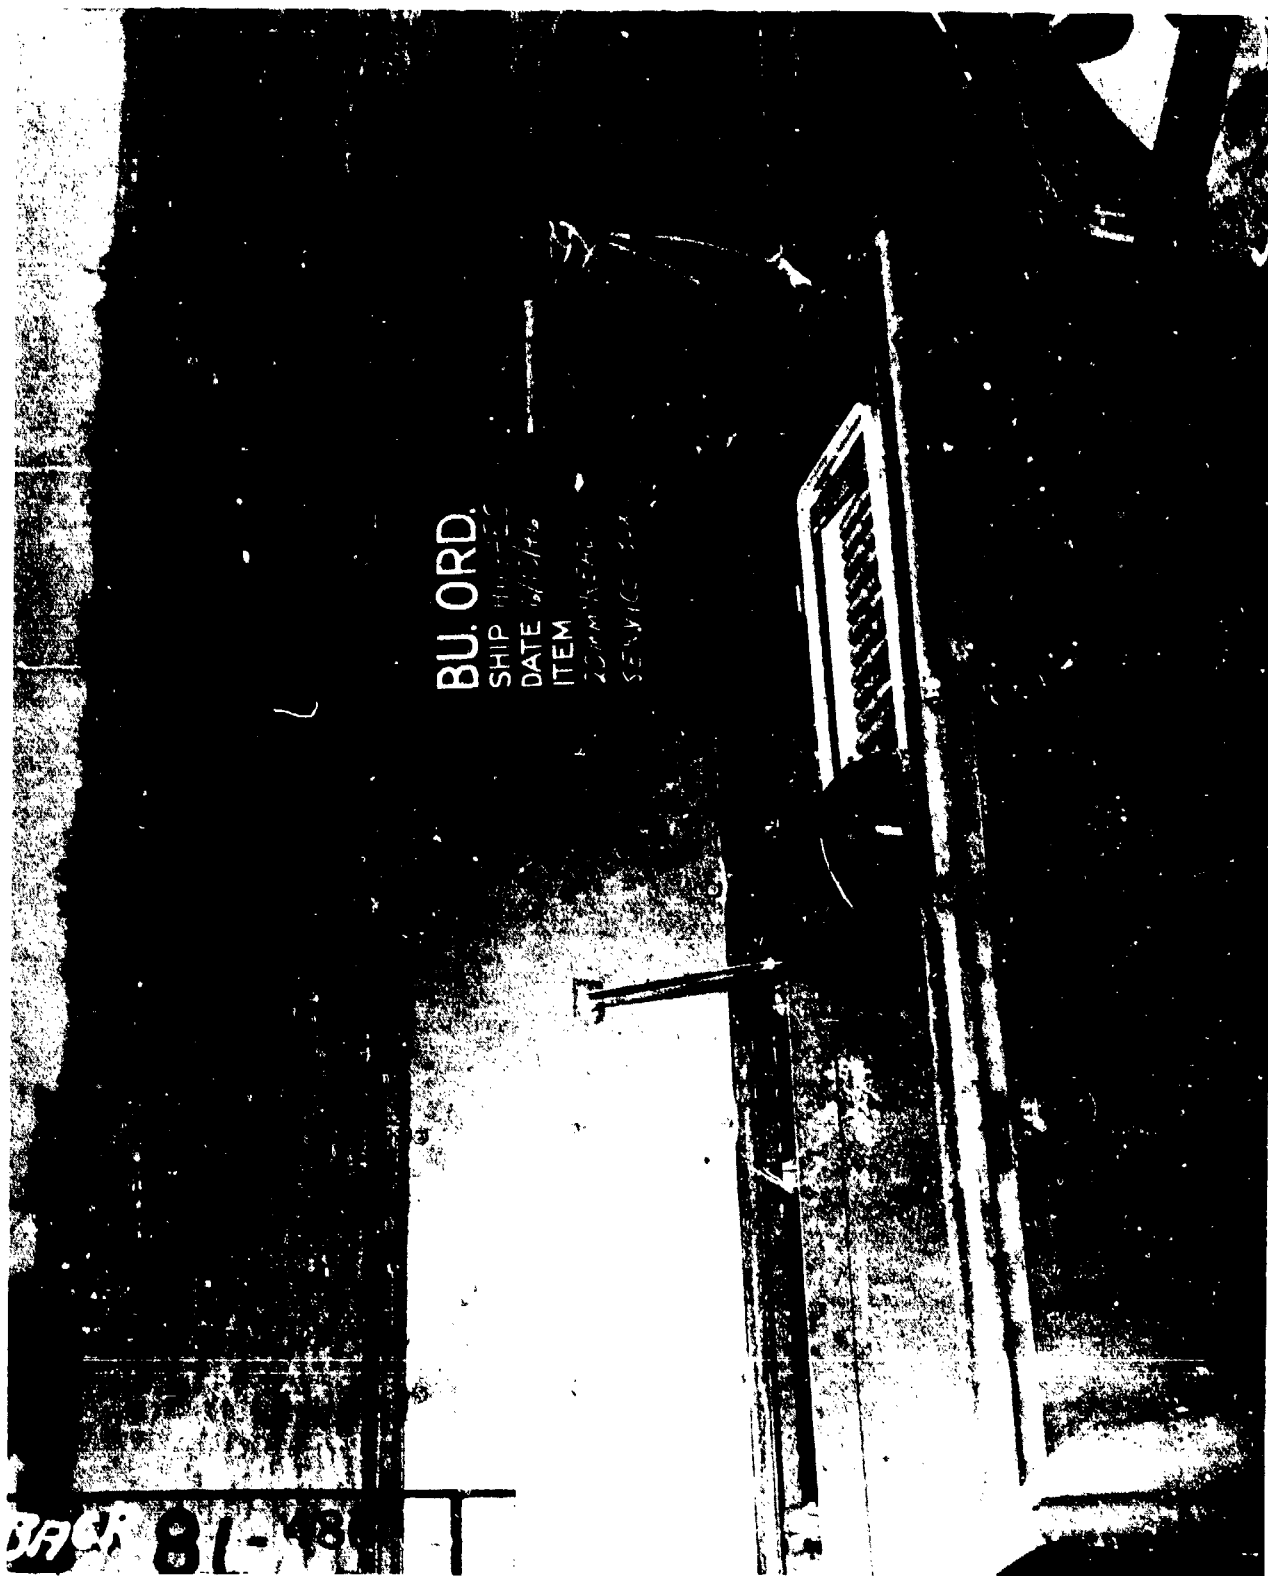
U.S.S. HUGHES (DD-410) - Before Able  
Shows the 20 MM Ammunition in position in the 20 MM  
Ready Service Box prior to Test "A".  
Photo. No. BA-CR-81-48-1.
